## CENTRAL INTELLIGENCE AGENCY This Document contains information affecting the National Defense of the United States, within the meaning of Title 18, Sections 793 and 794, of the U.S. Code, as amended. Its transmission or revelation of its contents to or receipt by an unauthorised person is prohibited INFORMATION REPORT by law. The reproduction of this form is prohibited. S-E-C-R-E-T 25X1 REPORT USSR (Ametic) COUNTRY MAR 25 1955 DATE DISTR. 25X1 **SUBJECT** Port of Murmansk NO. OF PAGES REQUIREMENT DATE OF INFO. 25X1 REFERENCES PLACE ACQUIRED 25X1 DATE ACQUIRED This is UNEVALUATED Information THE SOURCE EVALUATIONS IN THIS REPORT ARE DEFINITIVE. THE APPRAISAL OF CONTENT IS TENTATIVE. (FOR KEY SEE REVERSE) 1. 2. 25X1 double row of lights lying in a southwest to 3. northeast direction between Vayenga (N 69-05, E 33-27) and Rosta (N 69-03, 25X1 E 33-05). There were red and white lights in a row at least 10 small MTBs proceeding at high speed in the inlet. firing from a battery on 25X1 5. shore toward a vessel which was about four miles offshore. The shore battery was located on Voriv Point in the approximate position N 69-25, E 33-20. 25X1 The shots were fired in series; each series

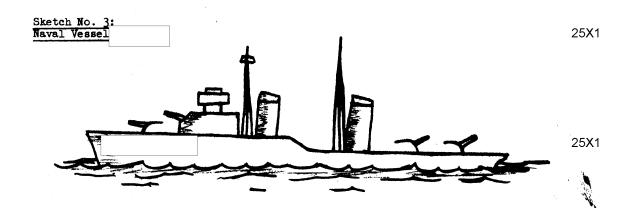
25X1 -2-7. There were a number of small vessels at the repair quay in Rosta. There were 25X1 also two identical vessels at anchor off the workshop Each vessel was about 350 feet long and had a break 25X1 in the deckline between the bridge and the forward stack. Each ship had two stacks equipped with smoke cowls, a tripod mast just forward of each stack, one gun turret on the foredeck, and a built-up structure and a number of guns on the 25X1 afterdeck. (see sketch No. 2). 25X1 8. There was a number of naval vessels on the west side of Roslyakova Bay (N 69-03, E 33-11). 25X1 9. On the south side of Vayenga Bay (N 69-05, E 33-26) there were many small naval vessels alongside the quay, and two large vessels at anchor in the bay. The two large vessels were very wide, and they were each about 350 to 400 feet long. One of the vessels had a break in the deckline between the stacks, and it had two stacks with smoke cowls, two tripod masts forward of each stack, a T-shaped 25X1 command bridge, and two gun turrets on both the foredeck and afterdeck. 25X1 On the forward mast there was a compact construction shaped like a truncated cone. 25X1 (see sketch No. 3). 25X1 10. The second vessel had a hull which was built up higher 25X1 (see sketch No. 4). The vessel had two stacks, and the after stack had a high-3.5 er smoke cowl than the forward one. There was a tripod mast located forward of each stack. The vessel also had a T-shaped command bridge, two gun turrets on both the foredeck and the afterdeck, and the same construction on the foremast There was a gangway on the port side at the break to the afterdeck25X1 (see sketch No. 4). Sketch No. 1: 25X1 Naval Vessel Sketch No. 2 25X1 Naval Vessel 25X1 S-E-C-R-E-T 25X1
